The Uniform Building Inspection Report™

Single Family Residence:
123 Main St., Happyville, CA

Report Number:
20071001

Plumbing Survey Findings:

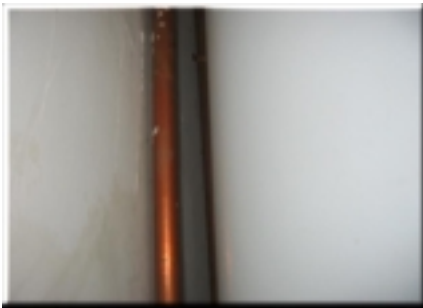
Photo: 4230.01 (1)

[R] 4230.01: Water heater seismic restraint straps not securing water heater against anything (wall or wood/metal blocking between water heater and wall). An Earthquake can move an insufficiently secured water heater and cause a gas leak that can be ignited by the burner and cause a fire or explosion. It is recommended that this finding and remaining water heater be reviewed and corrected as needed by a qualified licensed plumbing contractor. See Photo(s) 4230.01.

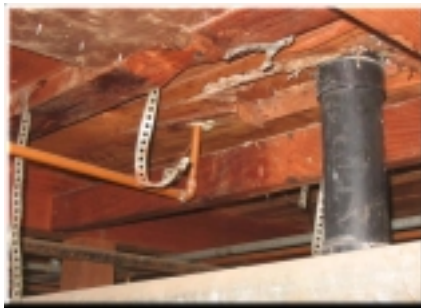
Photo: 4600.04 (1)

[R] 4600.04: Support strap for drain pipe in crawl space near guest bathroom is broken. Can stress pipes or cause improper slope. Recommend that this finding and all associated components be reviewed and corrected as needed by a qualified licensed plumbing contractor. See Photo(s) 4600.04.

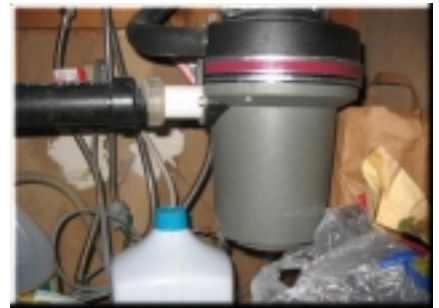
Photo: 4600.12 (1)

[R] 4600.12: Drain pipe from disposal is horizontal, possibly restricting drainage and promoting sludge/clogging. Drain should start going straight down before turning to a horizontal pipe. If drainage is poor, or if improvement is desired, it is

recommended that this finding and all associated components be reviewed, and corrected as needed, by a qualified licensed plumbing contractor. See Photo(s) 4600.12.

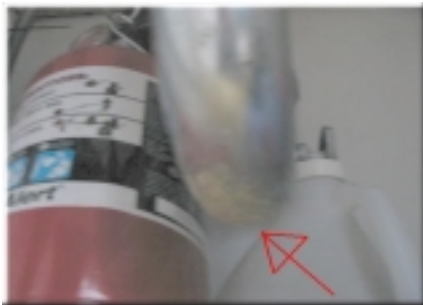
Photo: 4610.04 (1)

[R] 4610.04: Drain trap under laundry room sink appears to have corrosion. Could leak or fail over time. Recommend review, and correction if needed, by a qualified licensed plumbing contractor. See Photo(s) 4610.04.

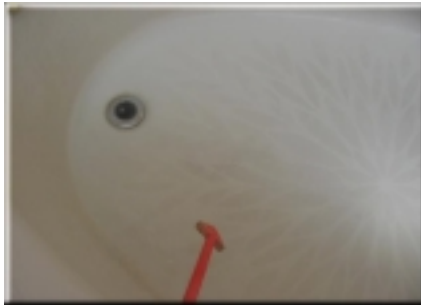
Photo: 4680 (1)

[R] 4680: Tub drain in guest bathroom is draining slowly. Various possible causes. Recommended that this finding and all associated components be reviewed, and corrected as needed, by a qualified licensed plumbing contractor. See Photo(s) 4680.

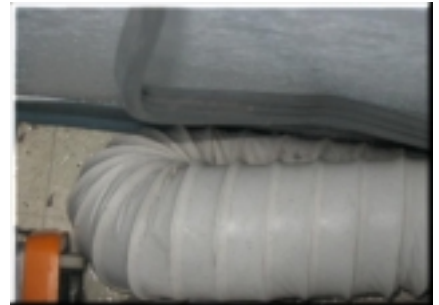
Photo: 4810.21 (1)

[R] 4810.21: Dryer vent is plastic type, which can collect lint, slow hot air flow, increase heat transfer to vent, and possibly cause the plastic and lint to burn and start a fire. A number of house fires are caused by this condition each year. Recommend vent constructed with metal in accordance with the clothes dryer's manufacturer's installation instructions be installed to exhaust to the exterior and terminate in an approved weather cap by a qualified licensed plumbing contractor. See Photo(s) 4810.21.
